## Belt Inspection Changes

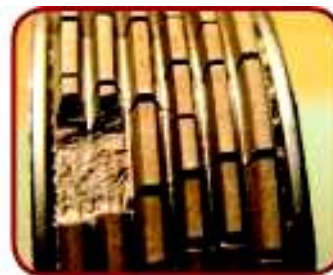
NEOPRENE

*Belt wear after 160,000 kilometers*

Standard industry belt diagnostics call for replacement of a serpentine belt if it shows three cracks in a three inch section. This is a good rule of thumb for Neoprene, but not so good for EPDM. EPDM belts inherently resist cracking because of the increased elasticity, so a visual check for cracks is not a very good indicator of true belt wear especially since they can run 160,000 kilometers or beyond with no visual cracks. A far better indicator of wear on EPDM belts is material loss.

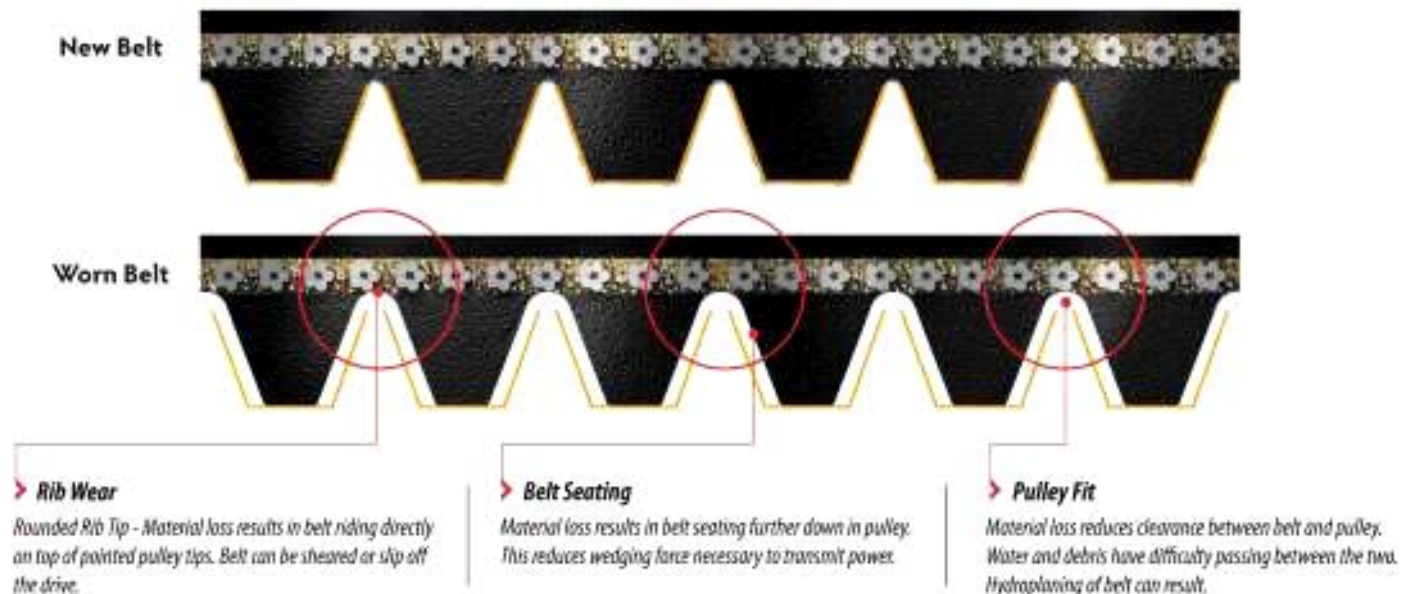
- Over time, belt ribs lose material
- With material loss the space between the ribs increases
- The belt can “bottom out” on the pulley
- This causes belt slip and accelerated wear
- When water cannot channel out between the belt and pulley, hydroplaning (like a tire on a wet road) can result

Serpentine belt drives are exposed to grit, rocks, salt and water. Over time, these contaminants along with slight misalignments result in wear of the rubber rib surface. Like tires running on a highway, serpentine belts gradually lose material over time which results in failure modes defined by changes in belt profile. One problem associated with material loss is how the belt fits around the pulley. Belts are designed to allow clearance between itself and the pulley. When material loss occurs, the clearance is lost; thus, eliminating a way for water and debris to be passed through the system. This can result in belt hydroplaning.

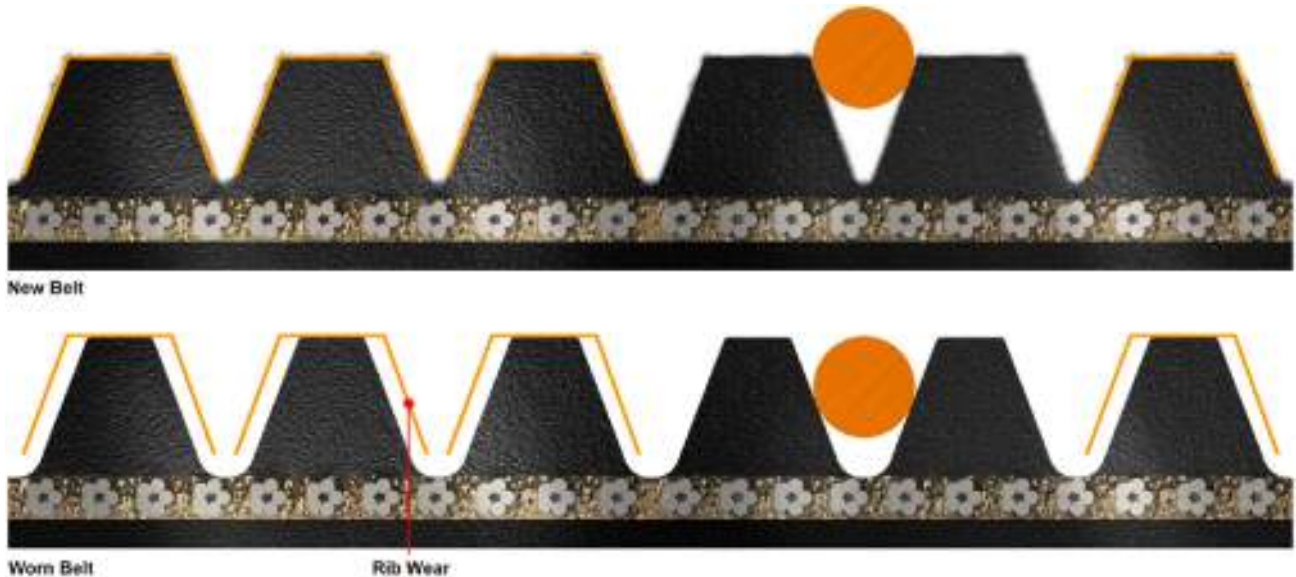
To measure belt wear a precision diameter (1.6 mm) tool can be set in the belt grooves. Place the long end of the tool between the ribs of the worn belt. If the tool sits high enough in the rib valley to expose the top of the tool the belt is okay. If the tool sinks into the valley between the ribs the belt has lost a significant amount of material and should be replaced. Look for a precision tool from ACDelco (available August 2009) to help in diagnosing belt wear.
